# Who Killed the Cover

A Chemical Guide  
19/02/2018 v2 daft

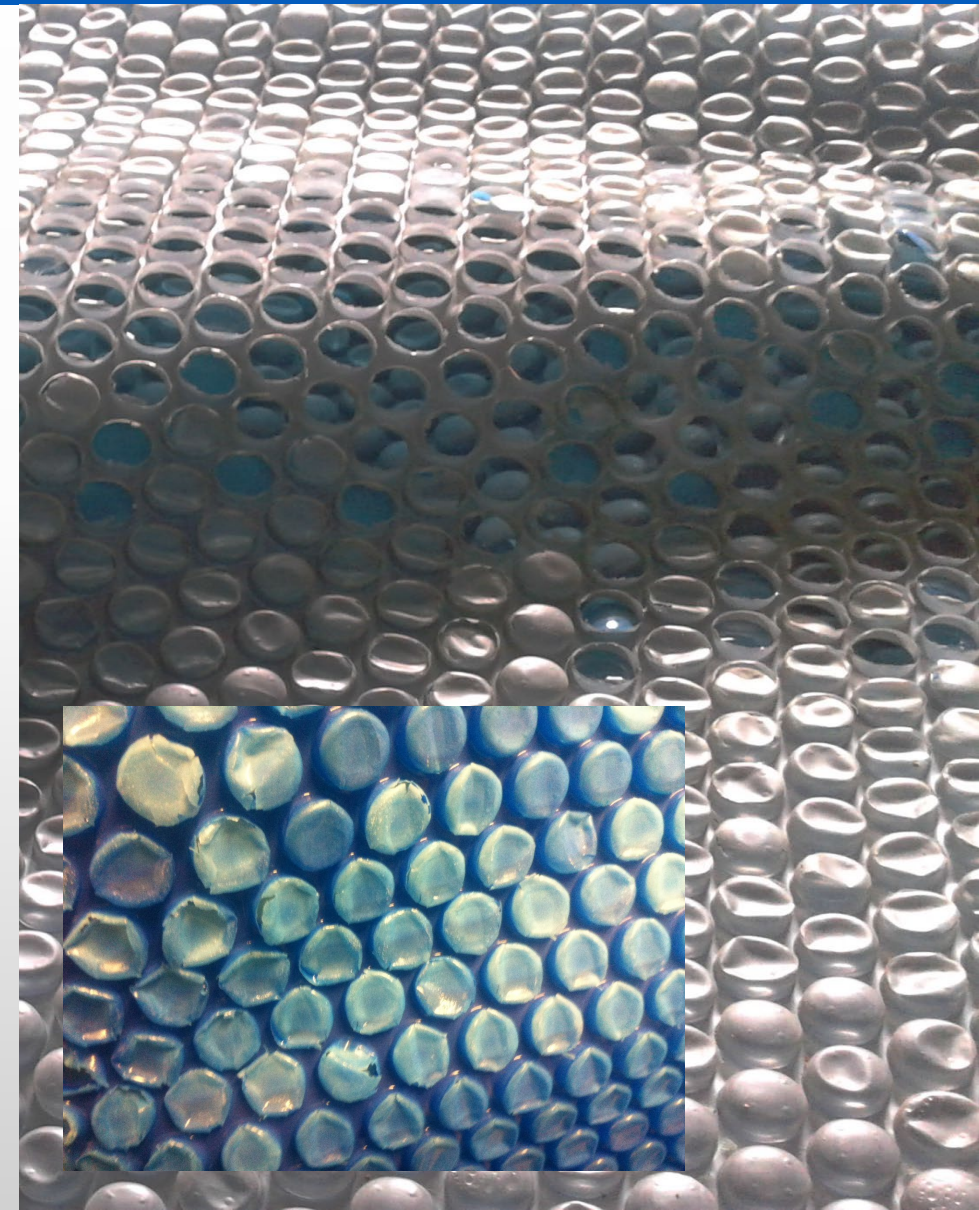
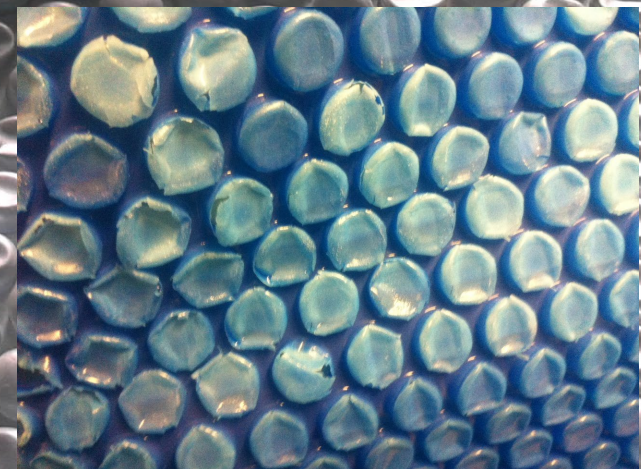
# Chemical Degradation

- Most issues involving premature degradation are the result of elevated chemical levels within the pool.
- Frequently, a sudden deterioration of the cover can be the result of a shock treatment.
- Noticeable effects:
  - Bleaching of the underside of the cover.
  - Bleaching of the hemming/edge.
  - Material has turned brittle - in particular on the bubble layer.
  - High residue amounts on the cover.
  - Oxidation of eyelets.
  - Strong chlorine smell.

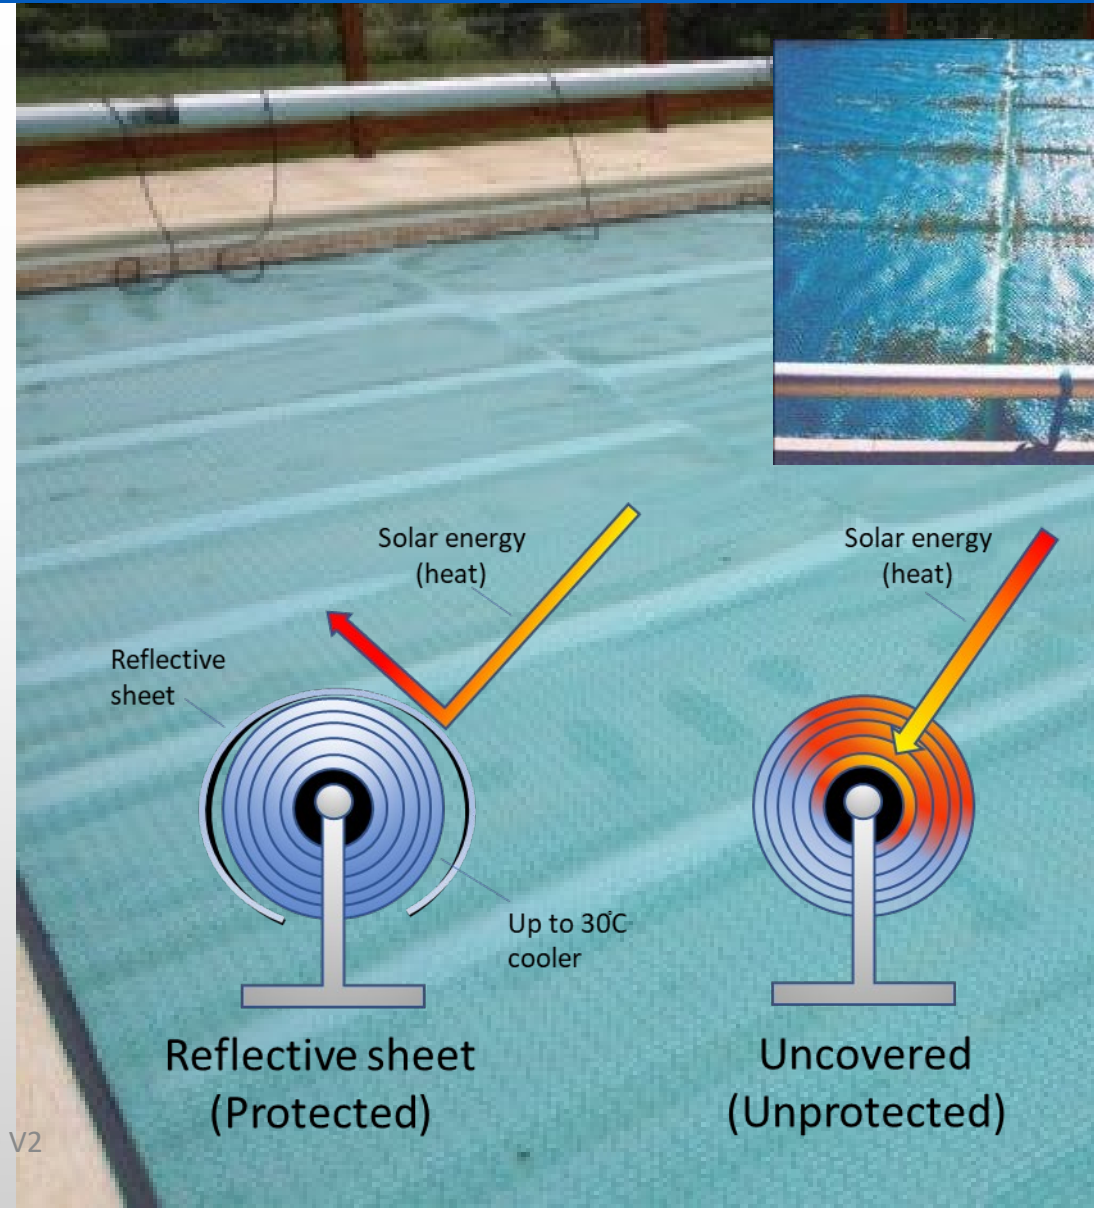
# Overheating on the Reel System

A sadly common issue of improper storage can be identified by the bands of poor lay flat occurring across the pool.

Usually these bands increase in frequency as they get closer to the reel system, or the folding edges when fan folded. This occurs when the cover is stored in direct sunlight for a prolonged period of time.

Bubble Covers (solar blankets) are designed to heat the water and insulate the pool to keep the heat in. When exposed on the reel system, this results in a rapid elevation in temperature at the centre of the roll. Tests conducted found temperatures of up to 80°C.

PE (polyethylene) is a thermoplastic which means it becomes malleable as the cover reaches its Vicat softening point. As the cover cools, the material sets to the shape of the reel and results in poor lay flat.

In extreme cases the covers can even oxidise or weld the layers of material together.

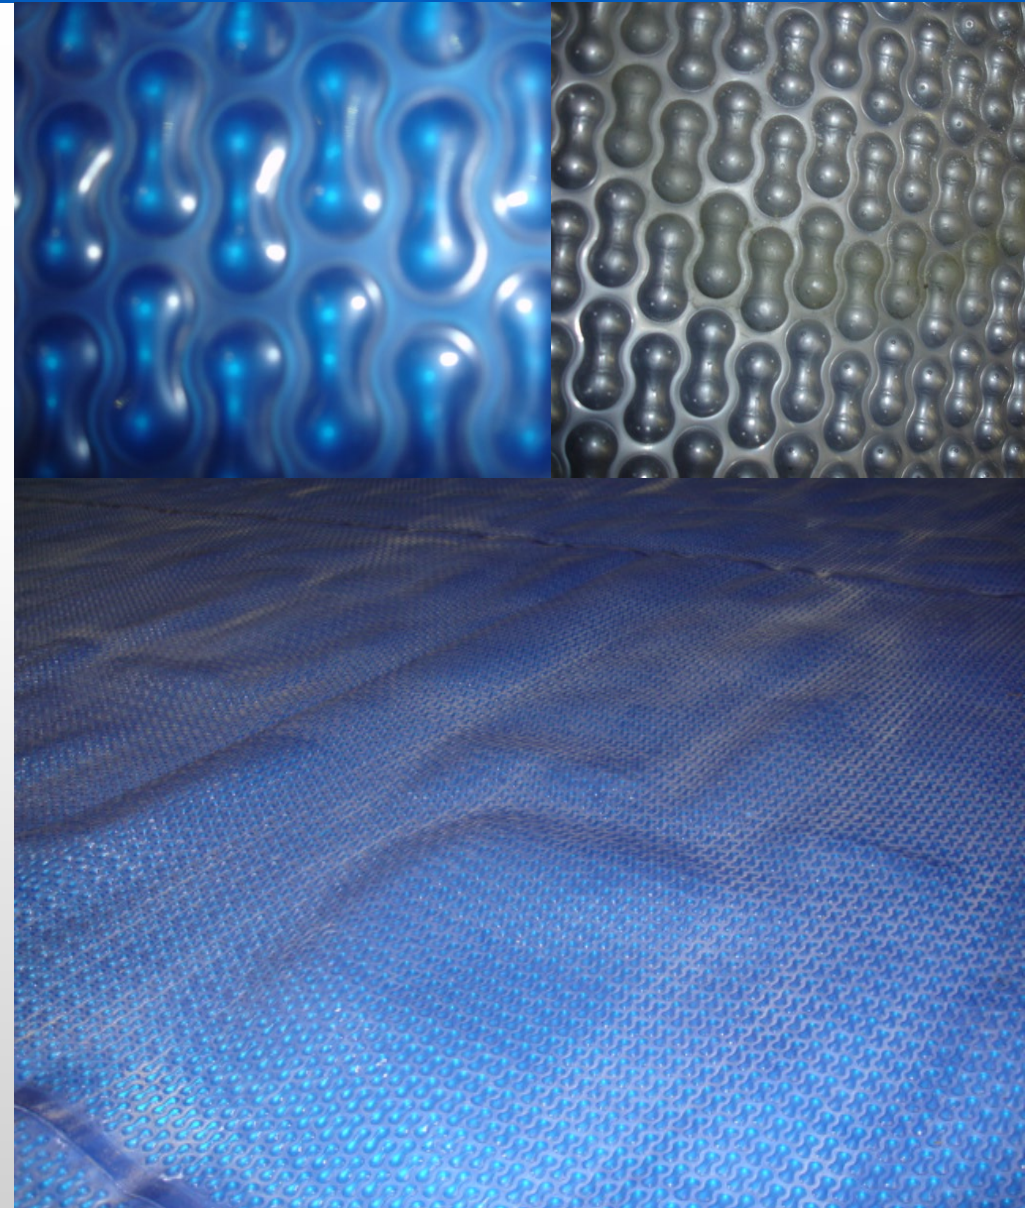
# Bubble Expansion

Bubble swell is a rare cause for complaint and is often mistaken for shrinkage.

Although it is not entirely clear what exact conditions produce this effect, key factors seem to be atmospheric pressure, pool temperature and chemical levels.

- The bubble will resist compression.
- The cover material will have the appearance of lumps in random patches of the cover.

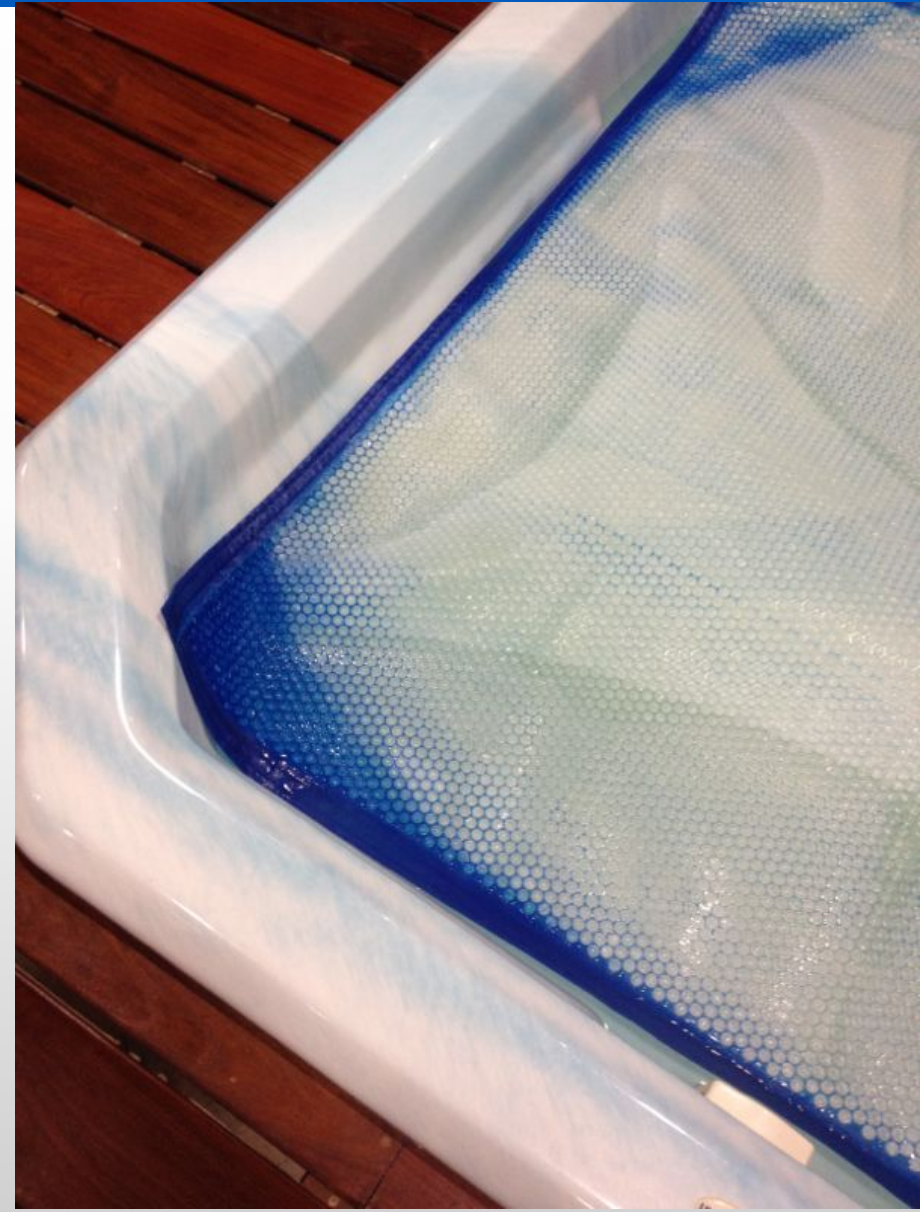
# Bleached pigment

When a cover has been bleached, this is the result of high chemical level and is often exacerbated by high temperatures such as on a hot tub.

In extreme cases like in this image the cover has been used on a hot tub and the combination of high chemical levels and higher temperatures have resulted in a dramatic change in the cover's appearance and properties.

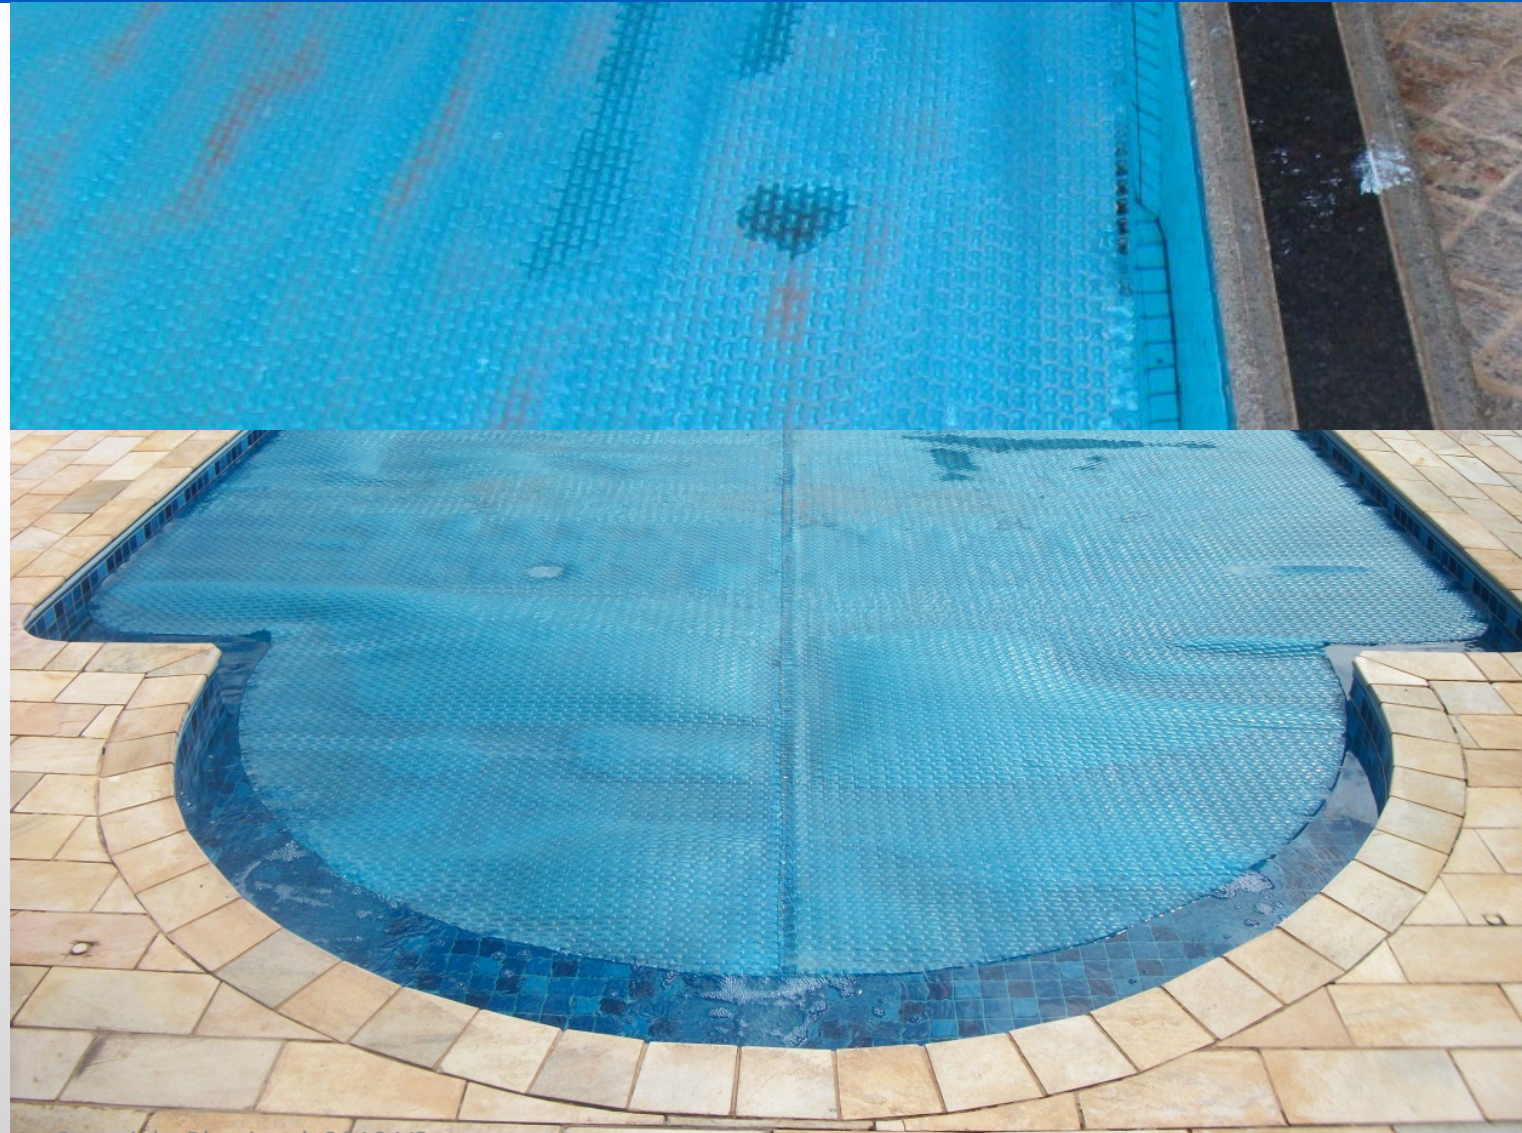
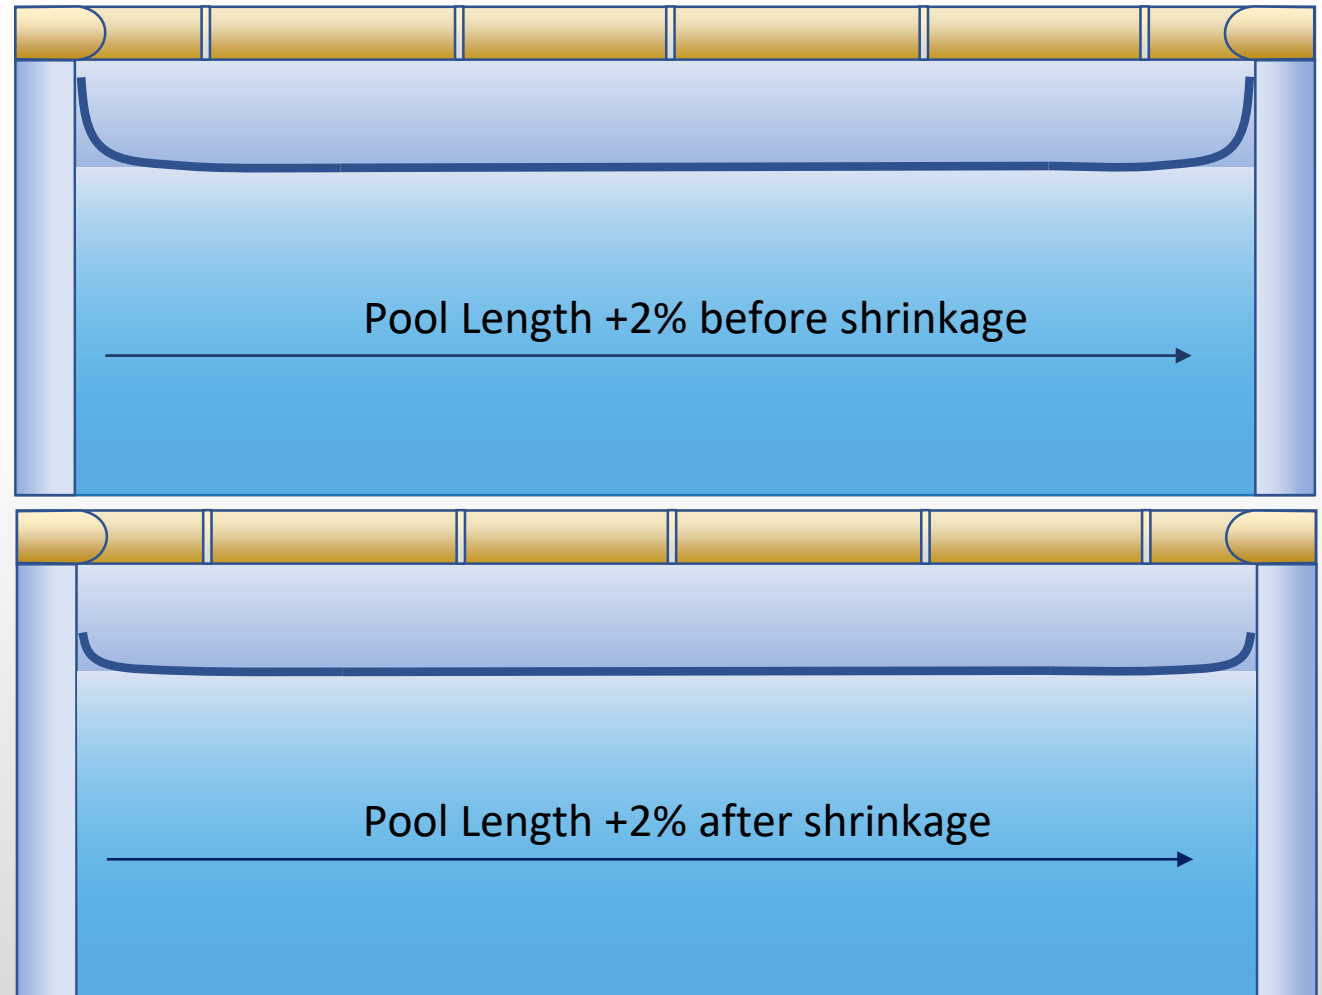
# Shrinking Cover

Shrinkage of the cover can happen and is usually exaggerated by bubble swell.

Shrinkage is the result of the polymer in the material releasing stress as it gains molecular mobility.

As a result of this Plastipack aims to remove as much stress from the material as possible. Because of this, should shrinkage be triggered, the material should only shrink between 1% and 2% of its total length.

It has become a common part of industry's best practice to oversize the cover by 2% in its length to allow for a small amount of shrinkage as the cover settles on the pool.

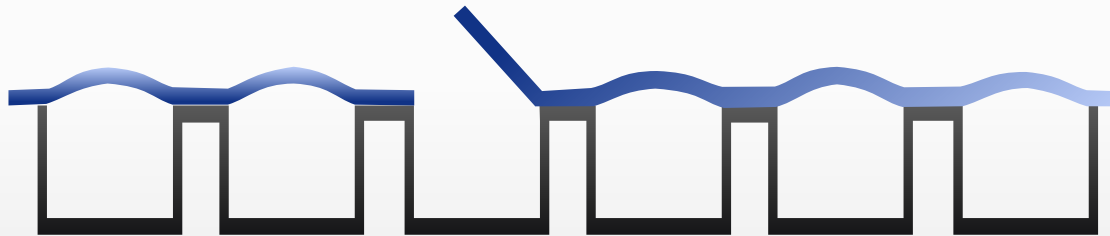
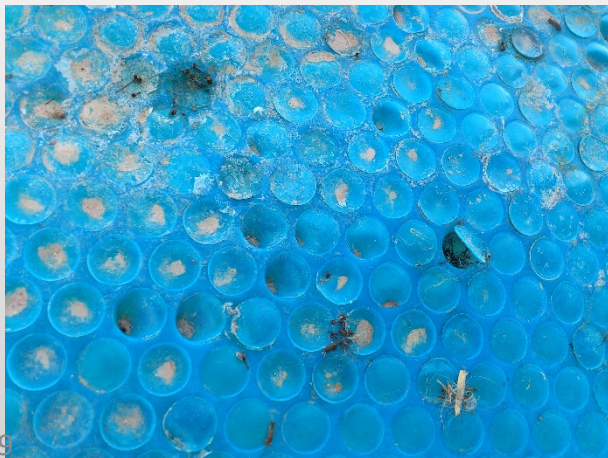
# Top Hating

Top hatting is where the flat top surface of the cover starts to come away from the material around the bubble profile.

Top hatting usually occurs as the cover starts to degrade either chemically or from UV as they reach the end of their lifespan.

However, this issue can also present itself from overheating. As discussed in the section “Overheating on the Reel System”, a cover could reach up to 80°C, which could cause permanent damage to the cover, even an issue such as top hatting.

With a well monitored chemical regime and appropriate storage provisions, this can often be prevented.

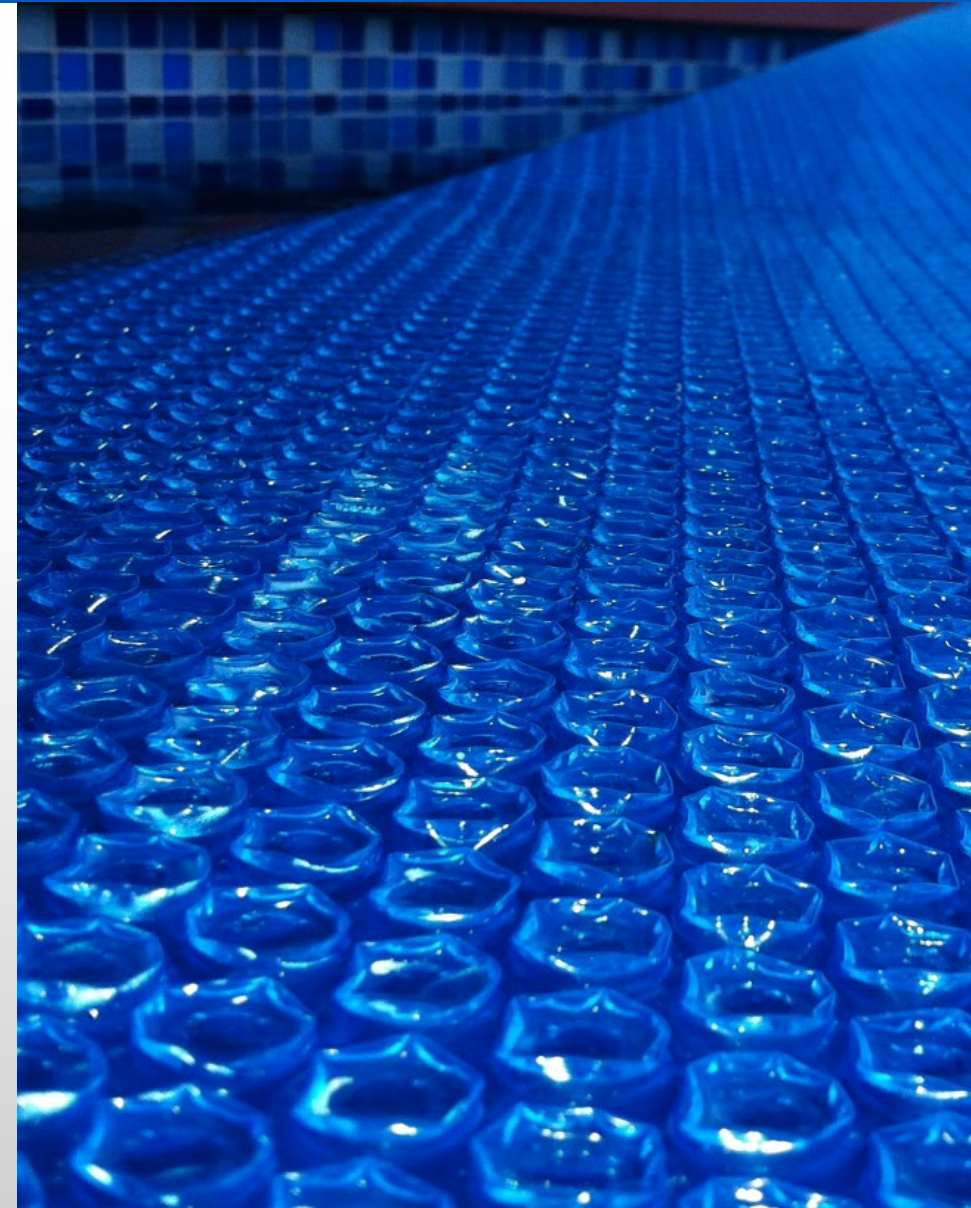
# Bubble Collapse

- Description:
  - The Bubbles on the under side of the cover deflate. Most commonly seen in 12mm materials as in the picture to the right.
- Cause:
  - This effect is very rare and can be caused by the build up of Nitrogen trichloride ( $\text{NCl}_3$ ) which is one of the chloramines produced by the reaction of Hypochlorous acid ( $\text{HOCl}$ ) and Ammonia ( $\text{NH}_3$ ), derivatives in the warm water.
  - This is often a indication of a building in TDS (total dissolved solids) and CC (Combined Chlorine).
- Solution:
  - The pool chemistry can be returned to balance by removing the cover and performing a break point chlorination or draining a portion of the loaded water and replacing with fresh.
  - Unfortunately once this has occurred the bubbles will not return to their previous state but actions taken to correct the issue will prevent this happen to a replacement cover.

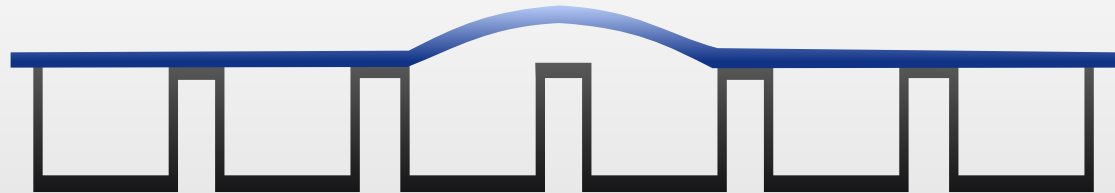
# Delamination

Delamination is incredibly rare and most often is the result of the cover overheating when being stored off the pool.

When folded or left exposed on a reel system, the material quickly heats up and causes the air within the bubbles to expand.

In extremely rare cases this can result in the air expansion forcing the layers of material at the land area of the bubble separating.

This can be avoided with the implementation of a reflective storage sheet.

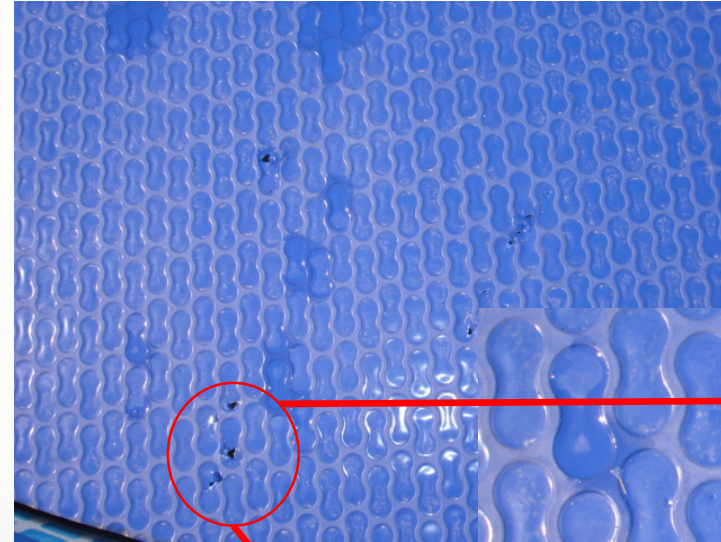
Herring Gull Attack!!

This is more common than would be imagined. Small groups of punctured or torn holes are often caused by birds.

We have found that a few CD's hanging from a string will cause reflections that discourage the birds from lingering around the pools.

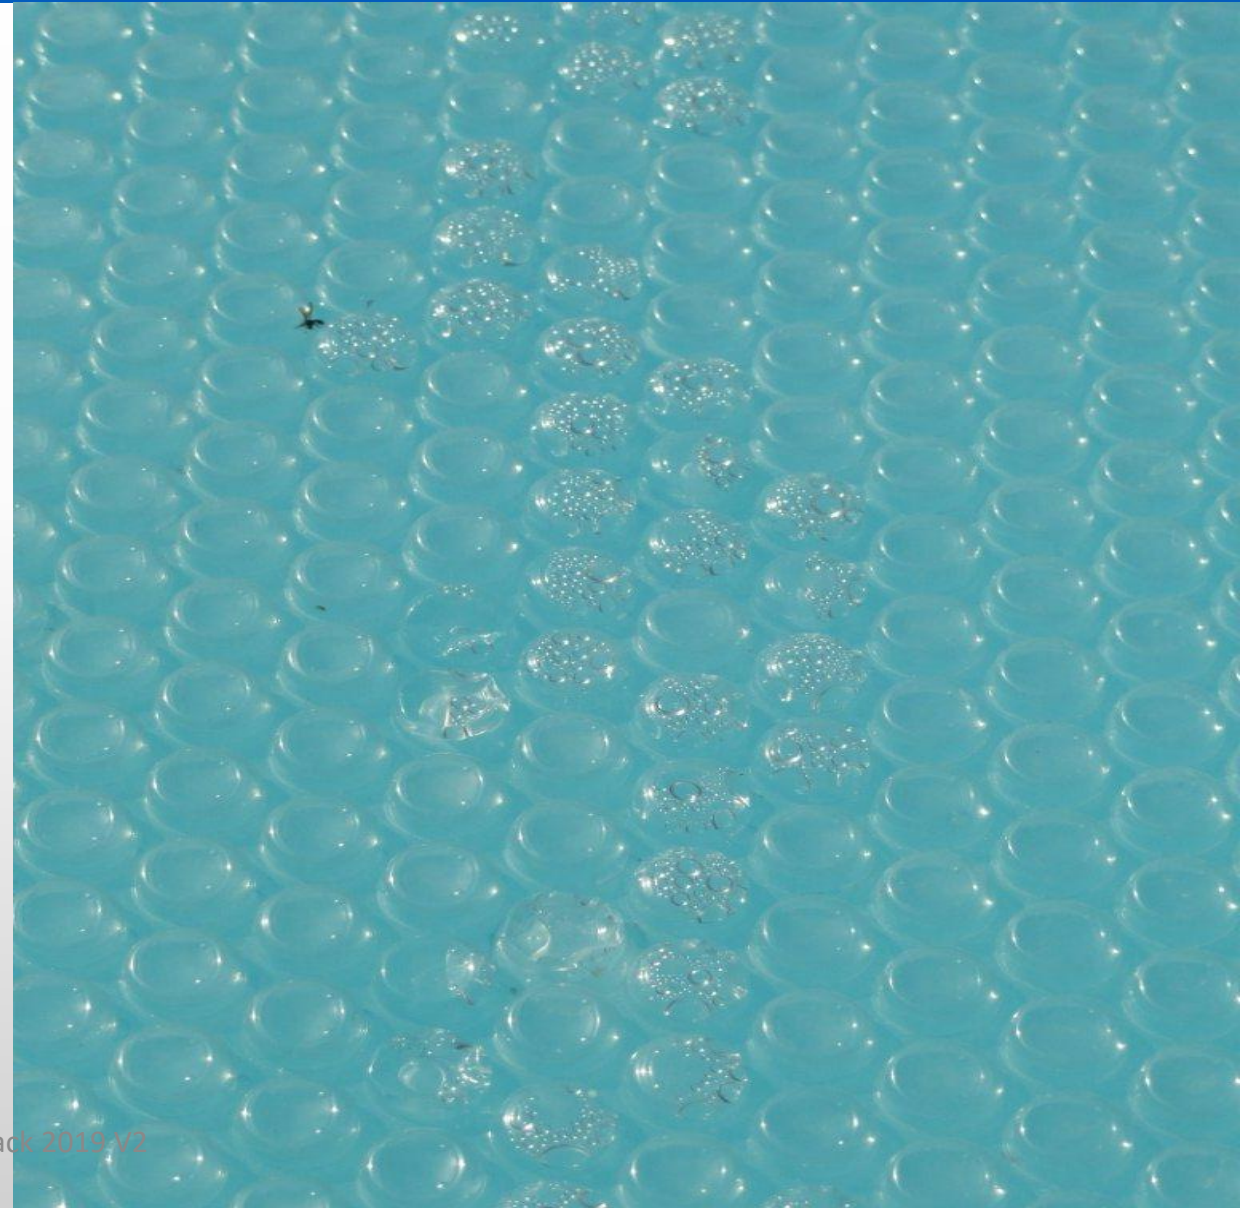
# Condensation

From time to time it may appear that small droplets of water have appeared within the bubbles.

This is the result of the water held as vapour with the air inside the bubbles condensing.

This is no cause for concern and is a natural result of a temperature difference between the pool and the air.

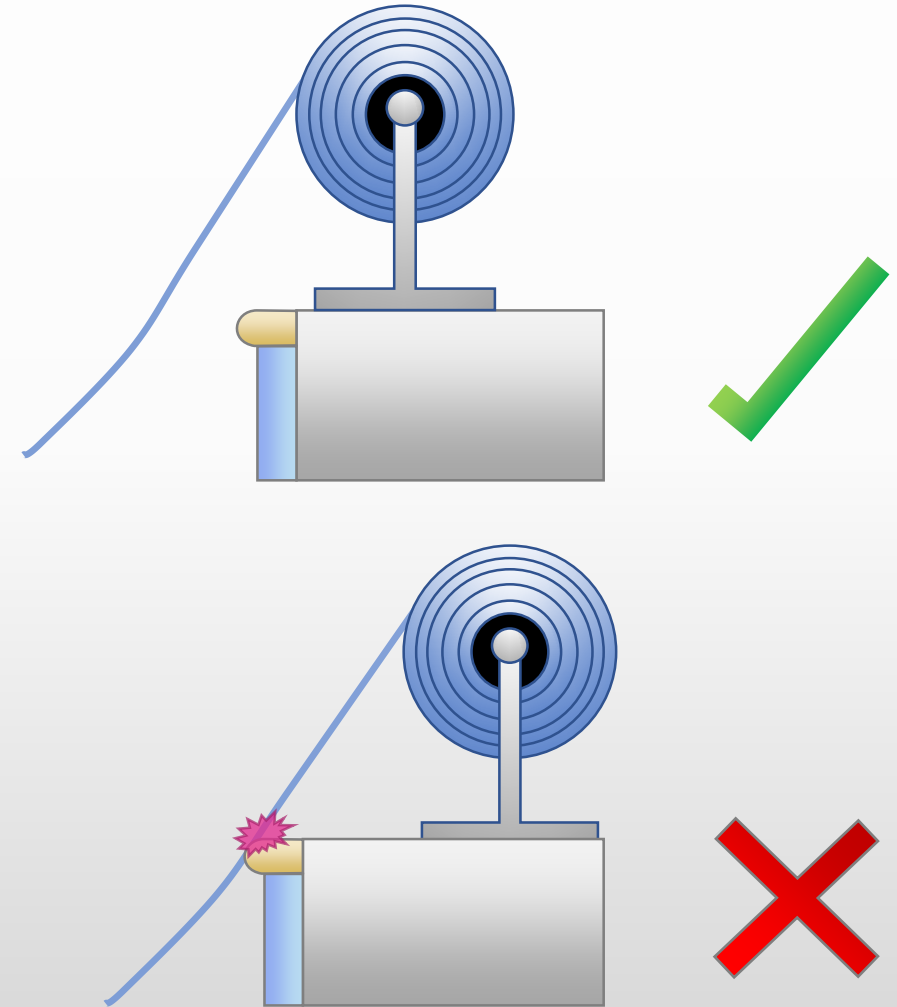
# Water incursion into bubbles

Usually the most noticeable sign that a bubble or bubbles across the cover have ruptured is the propagation of algae or the build up of debris within the bubble.

A common cause, usually produced when a reel system is set too far back from the pool or the cover is removed by hand, is a scuffing of the underside of the bubble. This causes a rupture through abrasion on rough surfaces and edges.

This is simple to identify by turning the cover over in the affected area and pressing down on the bubble. As the pressure builds you will see bubbles or water ejecting from the affected area.

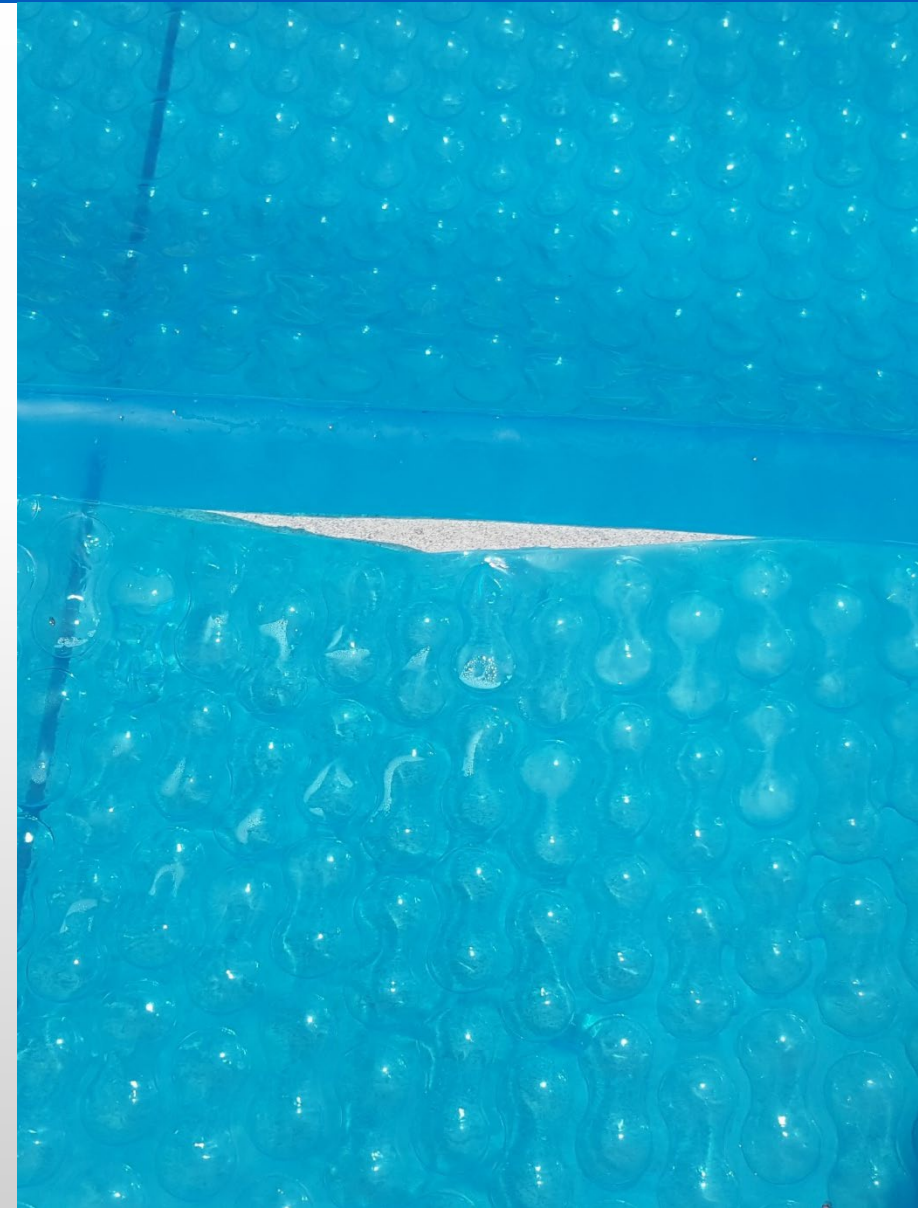
# Splits at the weld edge

A score line appears as a fine split next to the weld edge that shows no sign of polymer elongation.

Score lines are caused by damage to the material during welding. This can be caused by:

- Residue build-up on the wedge of the hot wedge welder.
- Dirt picked up from the floor being trapped on the wedge.
- Misalignment of the wedge.
- Too much compression from the pinch roller.

While there are tapes that can bond the materials together. This is not a permanent solution. If this occurs in the early days of the covers working life it is better to seek a replacement from the company who supplied the cover to you then attempt a repair.

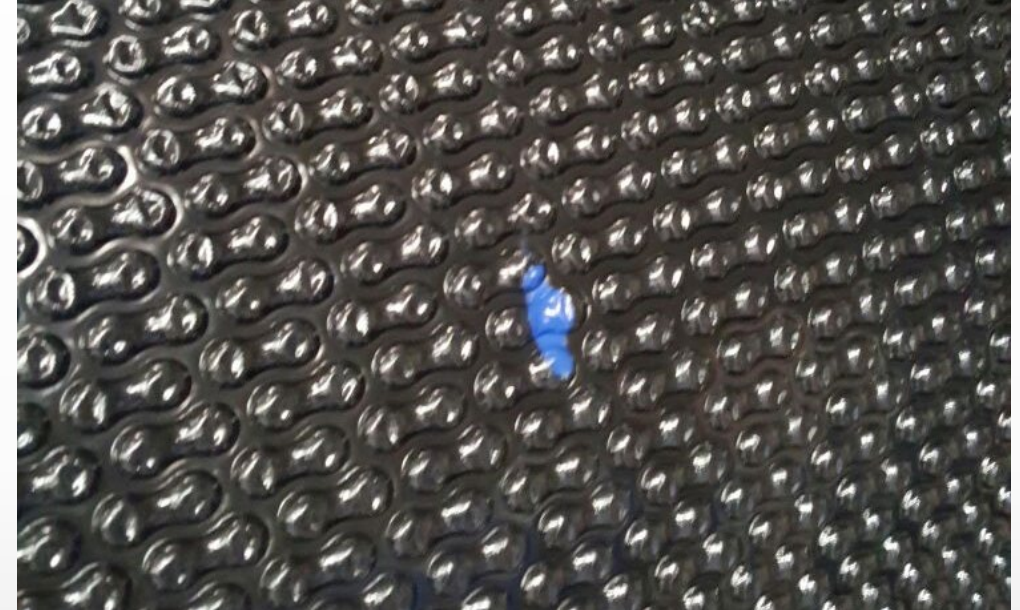
# Lensing

Lensing is caused by a rupture in one of the material films during production.

This can be caused by a process known as “gelling” from the polymers or from a un-melted or carbonised piece of polymer or debris working its through the production line.

This results in a tear-shaped deformation in the bubble. Lensing can appear in both the top and bubble layer.

If you receive a roll with lensing that renders the material unusable, please do not hesitate to contact us.
