# Who Killed the Cover

A Chemical Guide  
19/02/2018 v2 daft

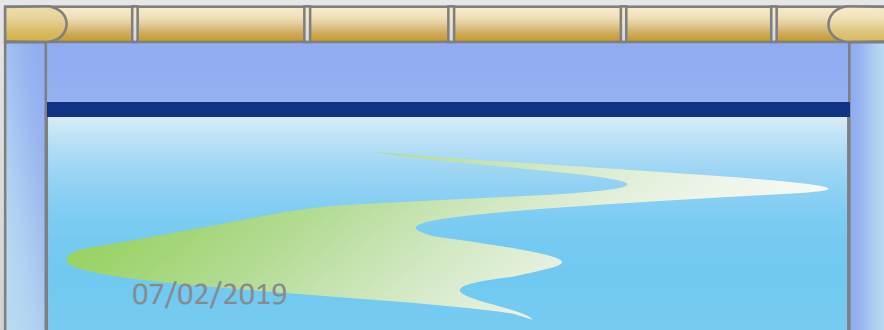
However, when a pool cover is left on during a shock dosing, the cover is exposed to the intense levels of the oxidant as well as trapping the by-products under the cover reducing the efficiency of the chemical treatment.

When the pool is outside of the industry recognised balance or when shock dosing the pool, it is important to remove the cover and only return it to the pool once oxidiser levels have stabilised.

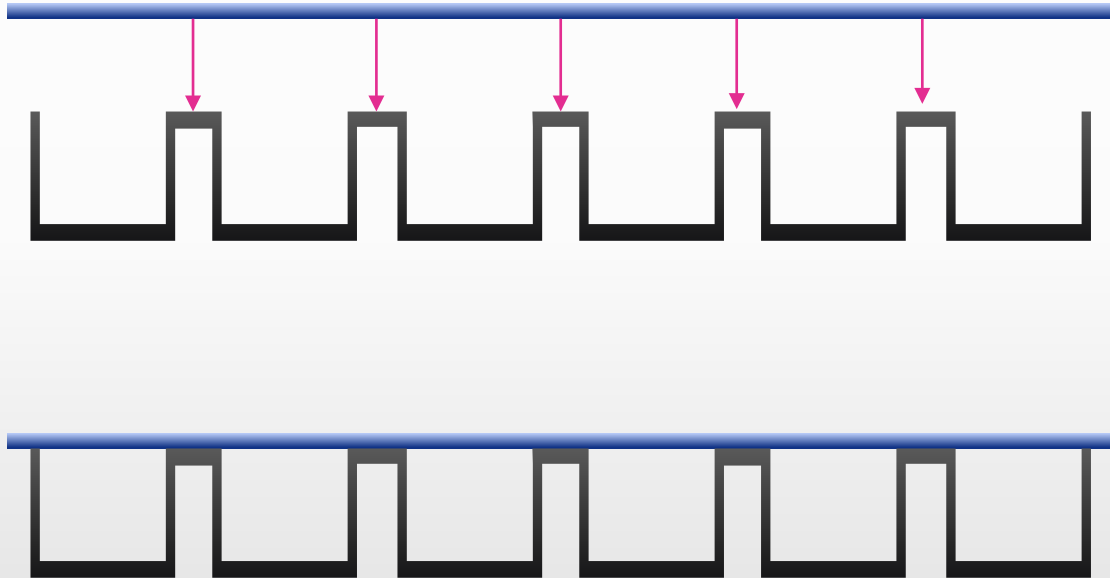
# Delamination

Our bubble materials are made of two layers of material a flat extruded top sheet and a extruded sheet that is vacuum formed into the bubble profile.

Just after the mould forms the bubble the top surface is laminated to the bubble

When folded or left exposed on a reel system, the material quickly heats up and causes the air within the bubbles to expand.

Should delamination occur without indications of improper storage please contact Plastipack immediately.
